**AMERICAN OPTICAL
CORPORATION**

TR 607-2

RESEARCH AND DEVELOPMENT OF
HIGH QUALITY LASER GLASS
SEMIANNUAL TECHNICAL REPORT
NUMBER 2

Period Ending 30 December 1968
ARPA Order No. 306
Contract No. N00014-68-C-0192

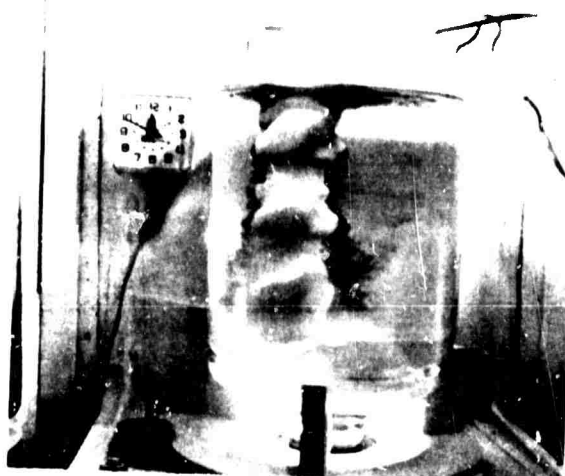
Figure 3. Stirring action with 3-tiered stirrer.

Typical results obtained with the equipment prior to its redesign are shown in Fig. 3. These experiments were carried out at a glycerin viscosity of 15 to 25 poises. The stirring rod is turning in a counterclockwise direction and the coloring solution is added at the top of a clear "melt." In Figs. 3b, 3c, 3d and 3e, one sees that the initial stirring action is one of wrapping a corkscrew of stria around the stirring rod. In Fig. 3e, this is still visible around the stirring rod although coloration in the rest of the melt is starting to obscure the action at the stirring rod. In Fig. 3f, the coloration of the rest of the melt completely masks any stirring action or lack thereof occurring at the stirring rod. For this reason the technique of adding a clearing agent to a "melt" which had previously been uniformly colored was adopted. As indicated by the clock, the first five pictures represent the initial twenty minutes of stirring in this experiment. The final picture was taken about two hours after the stirring experiment had been started.

While an experiment of the type shown in Fig. 3 is very useful in studying the type of stirring action which occurs, it does not show up dead zones which may exist in the stirring
